Subject: Boeing EQA Report on Slats, Passenger Windows, Fuselage, and Fan Cowl
Fragment - Southwest Airlines 737-700 N772SW Engine Failure and
Decompression Philadelphia, 17 Apr 2018

Equipment Quality Analysis Report

TO: Air Safety Investigation (ASI) **EQA NUMBER:** AS12821
DATE: September 20, 2018
MODEL NUMBER: 737-700
AIRPLANE NUMBER: YA070

SUBJECT: ***Examination of Damaged Components Removed from Southwest Airlines (SWA) Aircraft YA070***

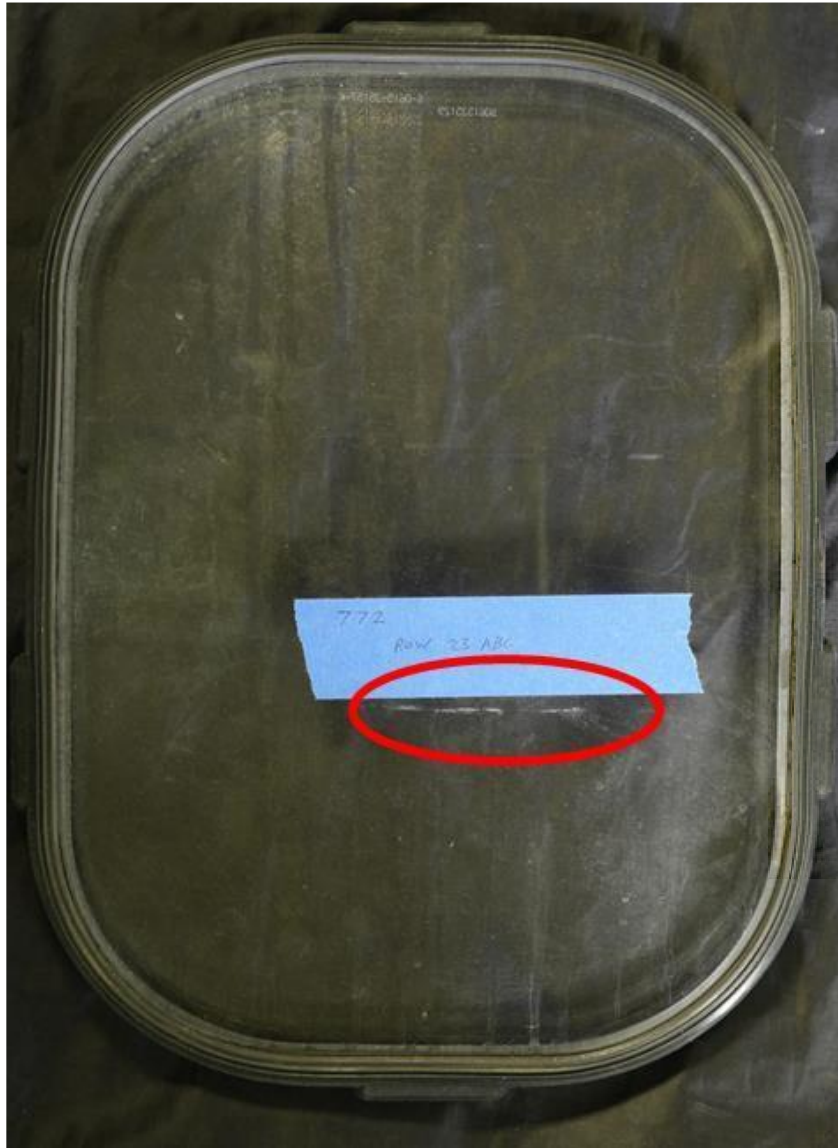
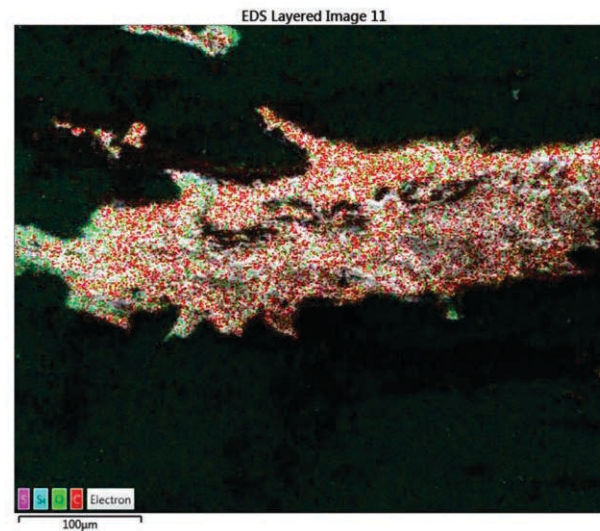
SEM Imaging – looking for metallic deposit in **Window Pane Covering #2** (Single Represented Image)

No trace amounts of Aluminum fragments were found in this sample. Present is Carbon, Oxygen, Silicon, and Sulfur

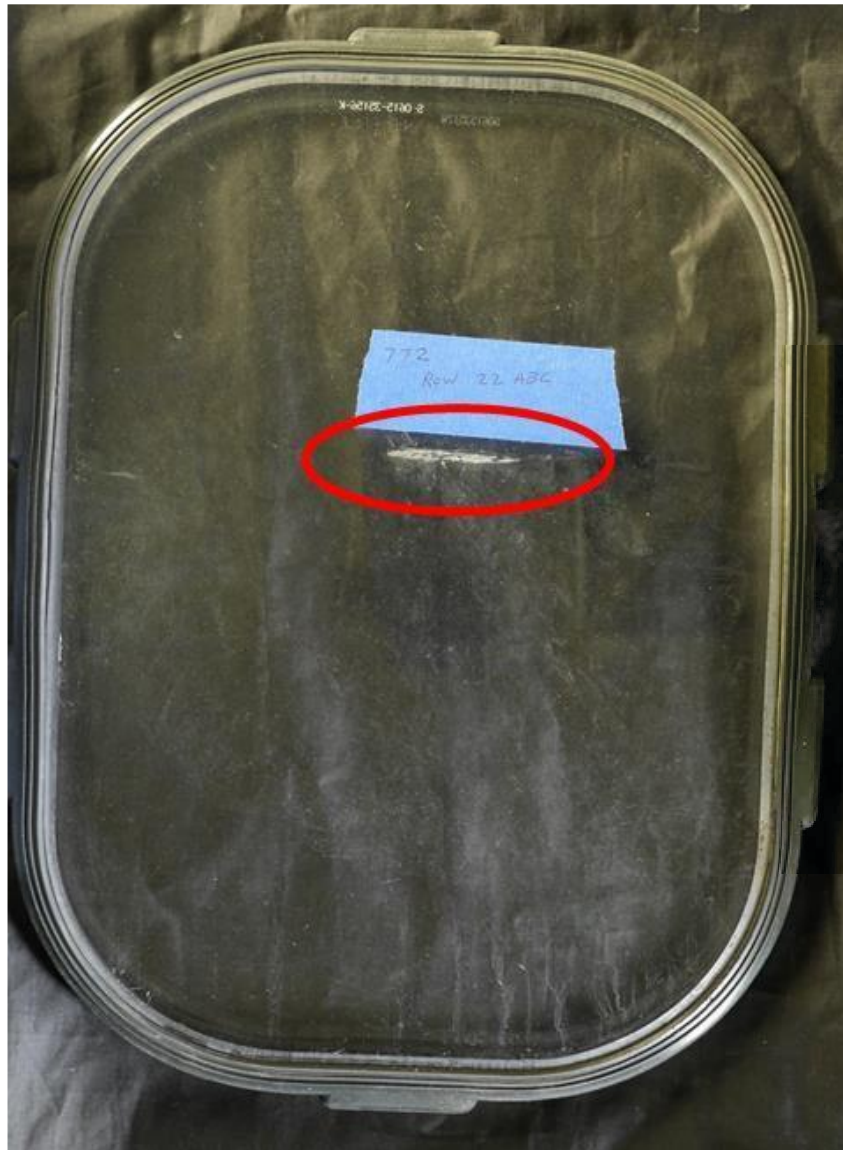
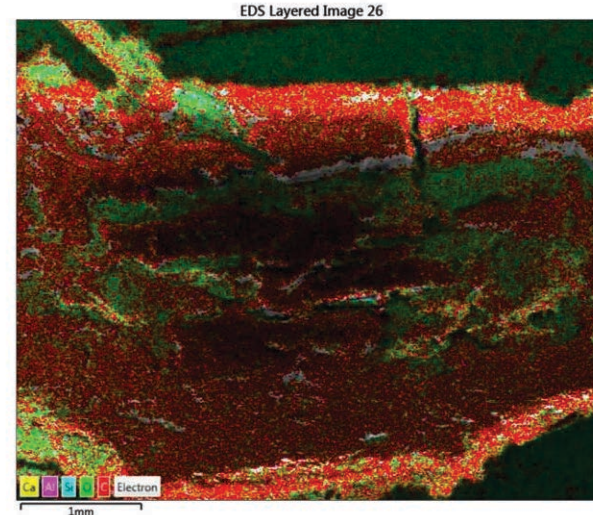
SEM Imaging – looking for metallic deposit in **Window Pane Covering #3** (Single Represented Image)

Trace amounts of Aluminum fragments were found in this sample. Also present is Carbon, Oxygen, and small amounts of Silicon

The Aluminum trace fragments most closely match the 7000 Series. An exact match is not possible due to the small particle size.

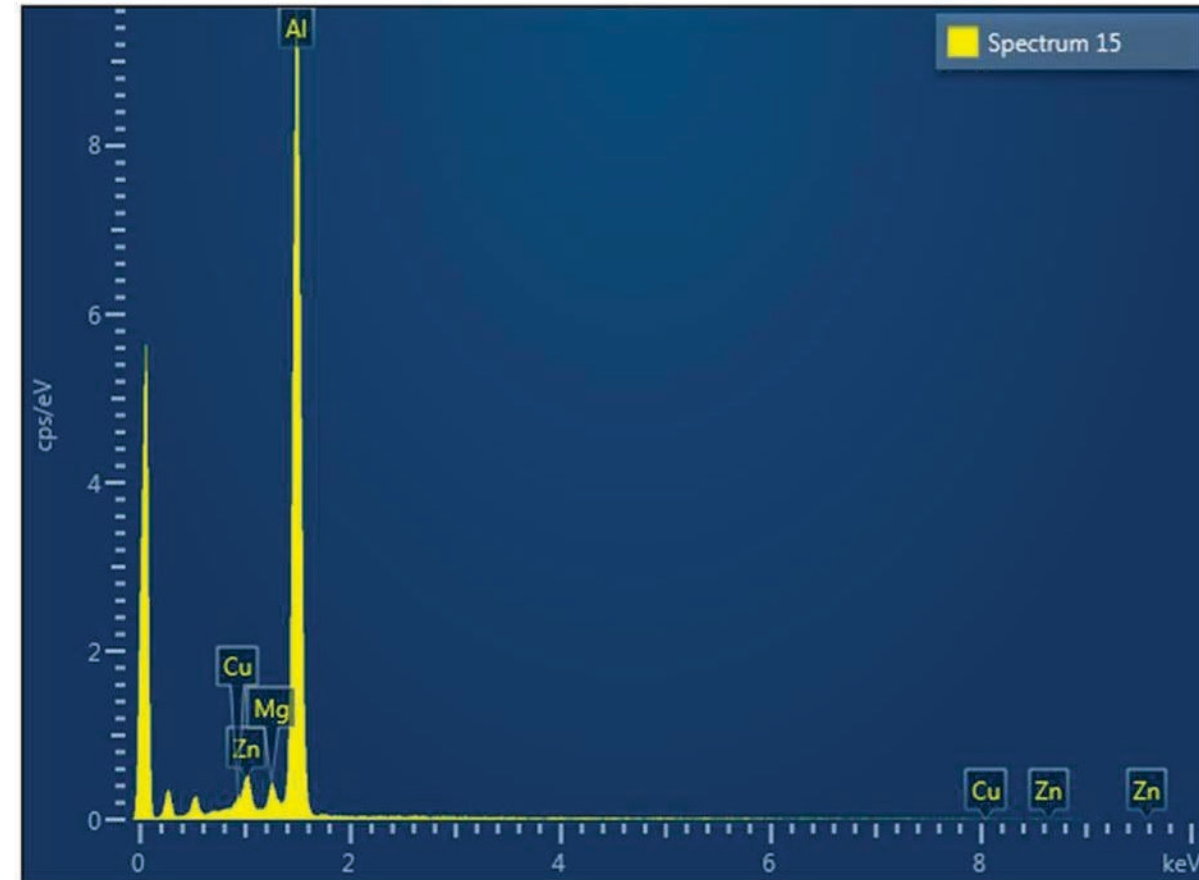
EDX Analysis – looking for metal composition **Slat #3 Fragment (Large)** (Single Represented Image)

Element	Wt%	Wt% Sigma
Mg	2.55	0.18
Al	88.80	0.60
Cu	2.11	0.46
Zn	6.54	0.43
Total:	100.00

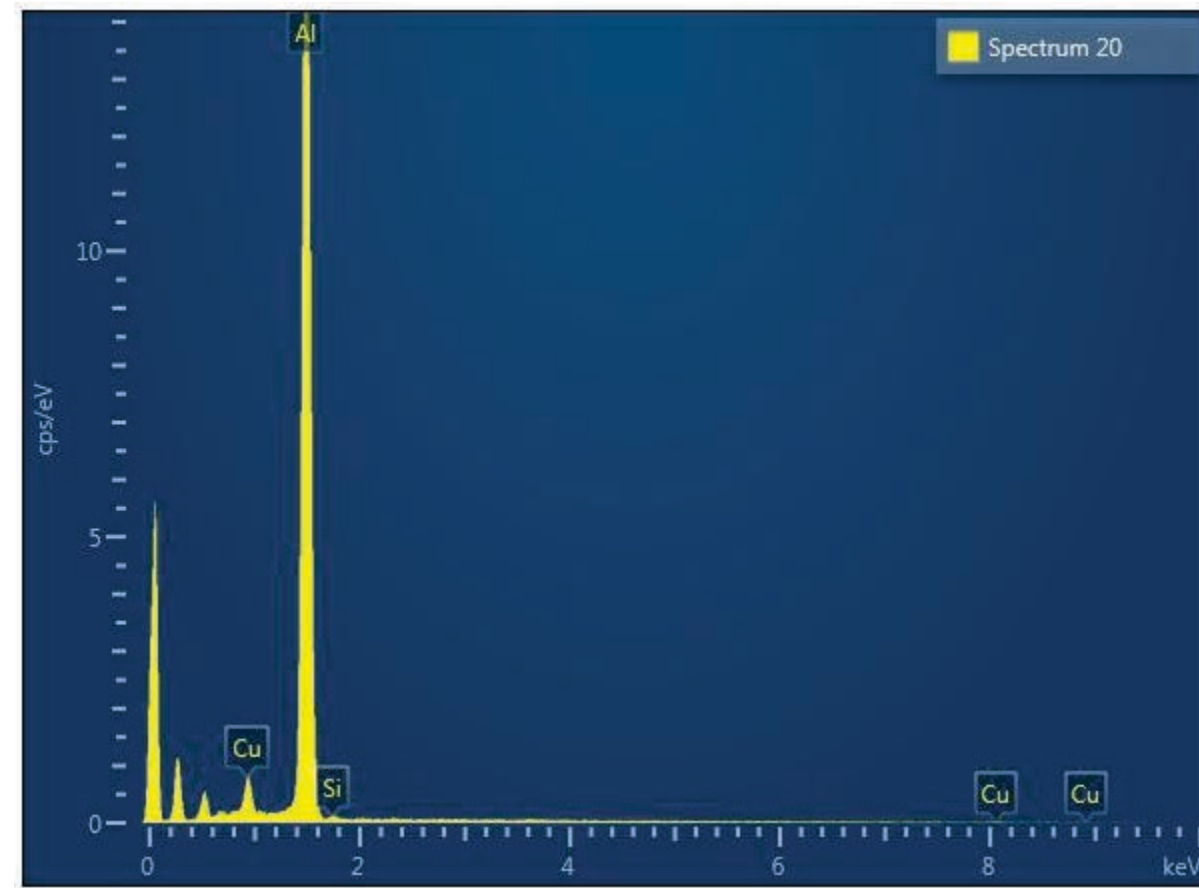
EDX Analysis - looking for metal composition **Fragment of inlet cowl assembly** (Single Represented Image)

Element	Wt%	Wt% Sigma
Al	93.72	0.26
Si	0.44	0.11
Cu	5.84	0.24
Total:	100.00
